# Access Compliance Report Public Rights-of-Way (Curb Ramps)

Main Street: **ORANGE\_PARK\_BLVD** Cross Street: **ORANGE\_PARK\_BLVD** Location: **SW**

ADA ID: **RPRK211222132736** Ramp Type: **Type 1 - Perpendicular Diagonal** Initial Pass/Fail: **Pass** Overall Compliance: **No** Severity Score: **5**

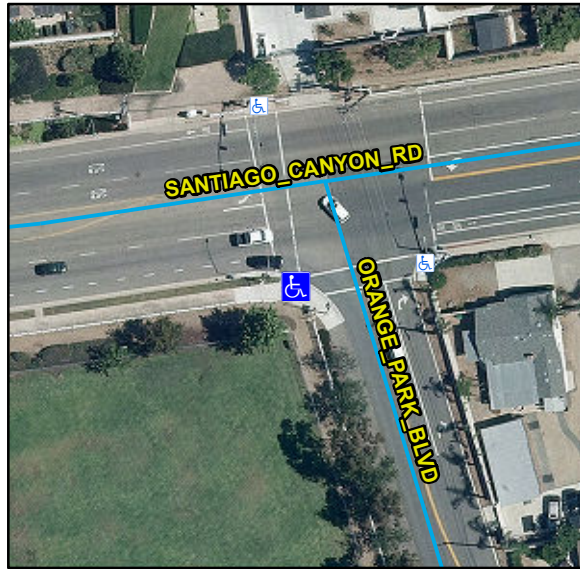
| Compliance | Description | Data | Compliance | Description | Data |
|---|---|---|---|---|---|
| <b>Yes</b> | Obstructions Present? | <b>No</b> | <b>N/A</b> | Utilities Present? | <b>Yes</b> |
| | Obstruction Dimensions | <b>N/A</b> | | <b>Pull Box</b> | |

| Compliance | Description | Data | Compliance | Description | Data |
|---|---|---|---|---|---|
| <b>No</b> | Gutter Run Slope (%) | <b>5.9</b> | | Road Cross Slope (%) | <b>2.8</b> |
| <b>No</b> | Gutter Cross Slope (%) | <b>2.2</b> | | | |

**Remove & Replace Gutter. Utility Present.**

**R304.5.4, R304.5.3, STD 1115**
