# Access Compliance Report Public Rights-of-Way (Curb Ramps)

Main Street: E\_JULIE\_AVE Cross Street: HEWES\_ST Location: SE

ADA ID: RPRK211222134821 Ramp Type: Type 4 - Parallel Initial Pass/Fail: Fail Overall Compliance: No Severity Score: 15

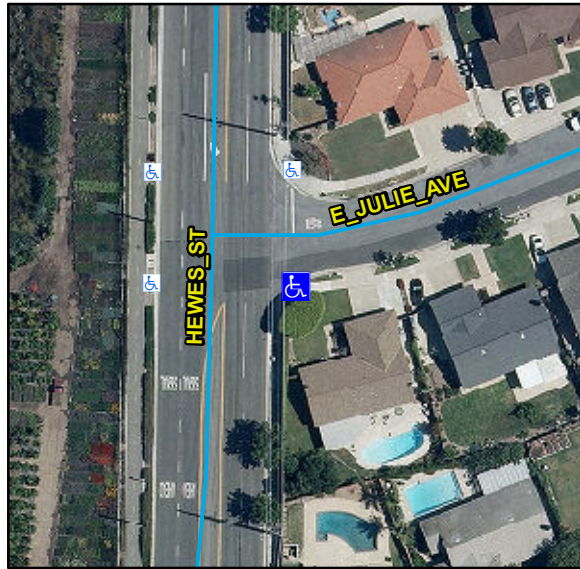
| Compliance | Description | Data | Compliance | Description | Data |
|---|---|---|---|---|---|
| No | Ramp Run Slope LT (%) | 8.4 | Yes | Ramp Run Slope RT (%) | 7.9 |

**Remove & Replace Curb Ramp With Two New Directional Ramps or Equivalent.**

**R304.3.2, STD 1115**

Total Cost: \$ 4000
