# Access Compliance Report Public Rights-of-Way (Curb Ramps)

Main Street: HEWES\_ST Cross Street: E\_JULIE\_AVE Location: NE

ADA ID: RPRK211222135101 Ramp Type: Type 4 - Parallel Initial Pass/Fail: Pass Overall Compliance: No Severity Score: 10

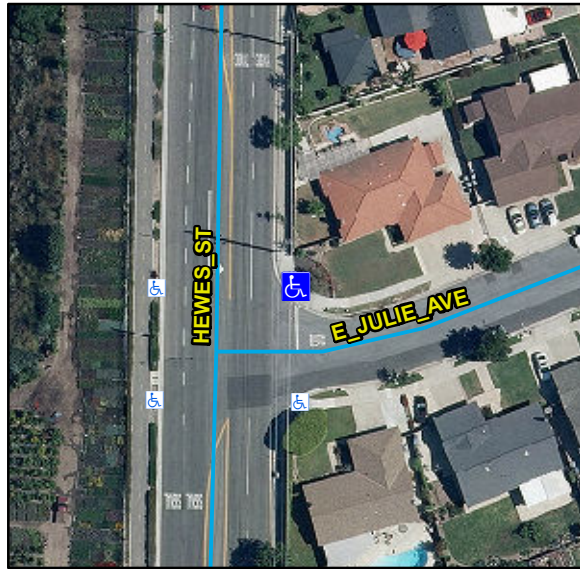
| Compliance | Description | Data | Compliance | Description | Data |
|---|---|---|---|---|---|
| No | Landing Run Slope (%) | 2.5 | No | DWS Full Width | No |
| No | Gutter Run Slope (%) | 9.7 | | Road Cross Slope (%) | 0.2 |

Remove & Replace Curb Ramp With Two New Directional Ramps or Equivalent. Remove & Replace Gutter.

R304.2.2-Perp, R304.3.2-Para, R305.1.4, R304.5.4, STD 1115
