# Access Compliance Report Public Rights-of-Way (Curb Ramps)

Main Street: VILLA\_PARK\_RD Cross Street: HEWES\_ST Location: NW

ADA ID: RPRK211222140438 Ramp Type: Type 1 - Perpendicular Initial Pass/Fail: Pass Overall Compliance: No Severity Score: 30

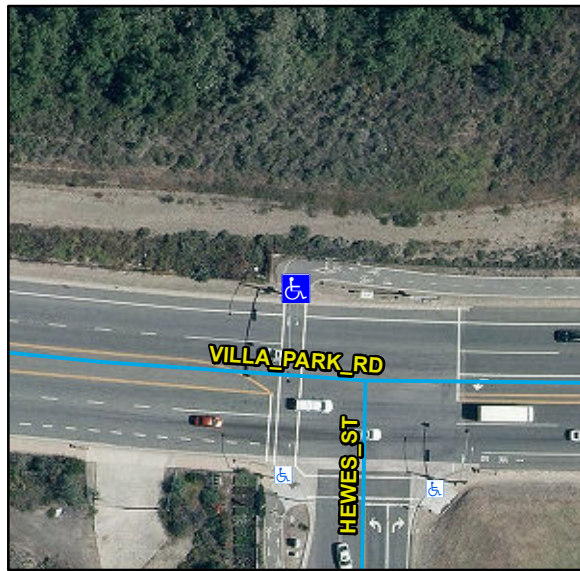
| Compliance | Description | Data | Compliance | Description | Data |
|---|---|---|---|---|---|
| No | Ramp Cross Slope (%) | 5.8 | N/A | Flare Traversable LT | N/A |
| No | Gutter Run Slope (%) | 8.2 | | Road Cross Slope (%) | N/A |
| No | Gutter Cross Slope (%) | 5.1 | | | |

Remove & Replace Entire Ramp. Remove & Replace Gutter.
