# Access Compliance Report Public Rights-of-Way (Curb Ramps)

Main Street: HEWES\_ST Cross Street: VILLA\_PARK\_RD Location: S

ADA ID: RPRK211222140900 Ramp Type: Type 1 - Perpendicular Initial Pass/Fail: Fail Overall Compliance: No Severity Score: 15

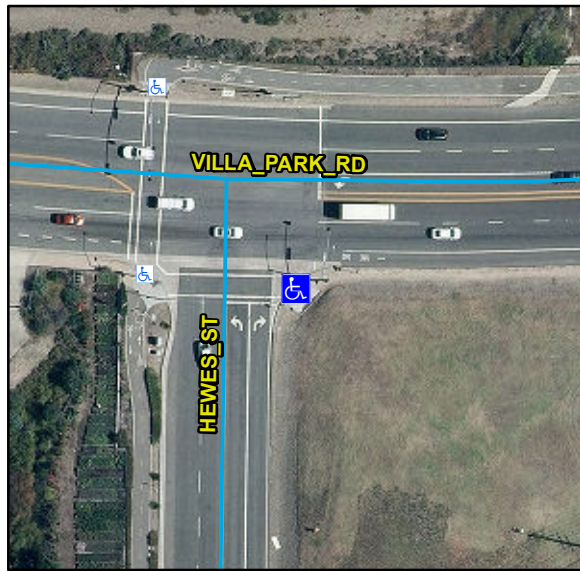
| Compliance | Description | Data | Compliance | Description | Data |
|---|---|---|---|---|---|
| No | Ramp Run Slope (%) | 8.4 | N/A | Flare Slope LT (%) | N/A |

Remove & Replace Entire Ramp.

R304.2.2, STD 1115
