# Access Compliance Report Public Rights-of-Way (Curb Ramps)

Main Street: VILLA\_PARK\_RD Cross Street: N/A Location: SW

ADA ID: RPRK211222143117 Ramp Type: Type 1 - Perpendicular Initial Pass/Fail: Fail Overall Compliance: No Severity Score: 30

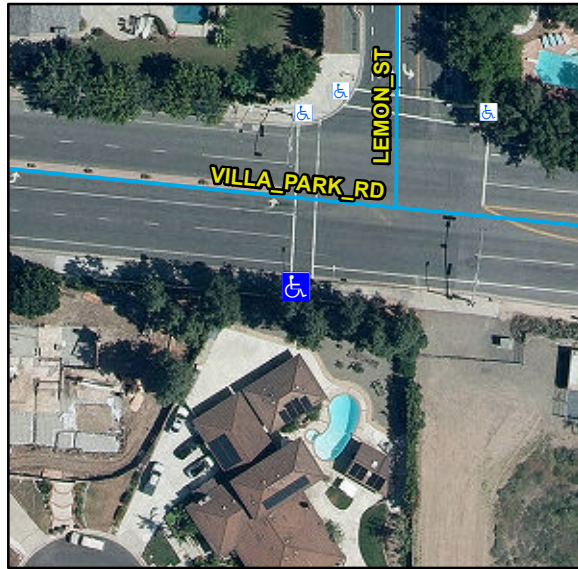
| Compliance | Description | Data | Compliance | Description | Data |
|---|---|---|---|---|---|
| No | Ramp Run Slope (%) | 13.8 | N/A | Flare Slope LT (%) | N/A |
| No | Gutter Lip Height (in) | 0.25 | | Road Run Slope (%) | N/A |

Remove & Replace Entire Ramp. Grind Gutter Lip.

R204.3, R304.2.2, R302.7.2, STD 1115
