# Access Compliance Report Public Rights-of-Way (Curb Ramps)

Main Street: BOND\_AVE Cross Street: GRAVIER\_ST Location: SE

ADA ID: RPRK211223110857 Ramp Type: Type 1 - Perpendicular Diagonal Initial Pass/Fail: Pass Overall Compliance: No Severity Score: 4

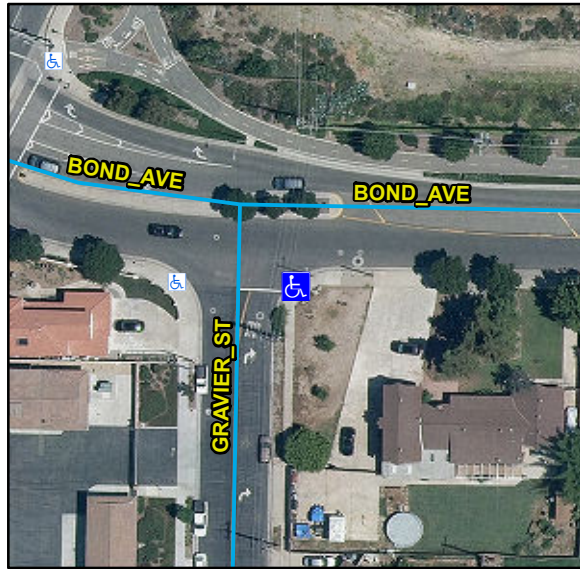
| Compliance | Description | Data | Compliance | Description | Data |
|---|---|---|---|---|---|
| N/A | Landing Length (in) | 47 | | | Sloped |
| N/A | Landing Movement Obstructed? | Yes | Yes | DWS Contrast | Yes |
| | Landing Movement Type | Curb | Yes | DWS Length (in) | 36 |

Remove & Replace Landing.

R304.2.1, STD 1115

Total Cost: \$ 531
