# Access Compliance Report Public Rights-of-Way (Curb Ramps)

Main Street: GRAVIER\_ST Cross Street: BOND\_AVE Location: SW

ADA ID: RPRK211223111217 Ramp Type: Type 1 - Perpendicular Diagonal Initial Pass/Fail: Fail Overall Compliance: No Severity Score: 16

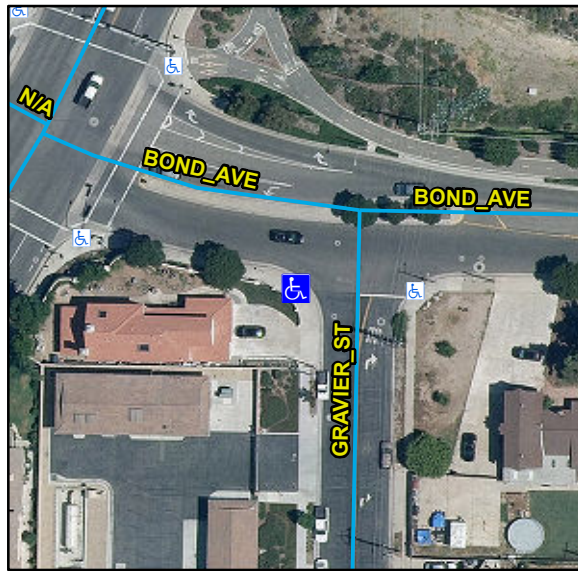
| Compliance | Description | Data | Compliance | Description | Data |
|---|---|---|---|---|---|
| No | Ramp Run Slope (%) | 9 | N/A | Flare Slope LT (%) | N/A |
| No | Ramp Cross Slope (%) | 2.4 | N/A | Flare Traversable LT | N/A |

Remove & Replace Curb Ramp With Two New Directional Ramps or Equivalent.

R304.2.2, R304.5.3, STD 1115
