# Access Compliance Report Public Rights-of-Way (Curb Ramps)

Main Street: E\_BOND\_AVE Cross Street: S\_ESPANITA\_ST Location: SE

ADA ID: RPRK211223111924 Ramp Type: Type 4 - Parallel Initial Pass/Fail: Fail Overall Compliance: No Severity Score: 15

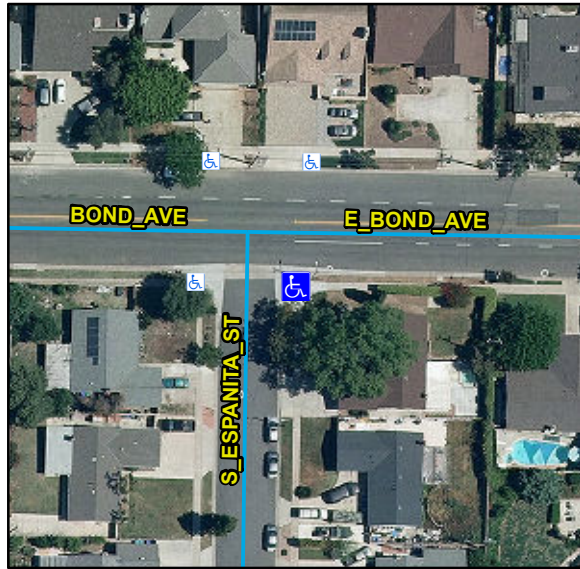
| Compliance | Description | Data | Compliance | Description | Data |
|---|---|---|---|---|---|
| Yes | Ramp Run Slope LT (%) | 6.8 | No | Ramp Run Slope RT (%) | 8.5 |

Remove & Replace Curb Ramp With Two New Directional Ramps or Equivalent.

R304.3.2, STD 1115
