# Access Compliance Report Public Rights-of-Way (Curb Ramps)

Main Street: **ESPLANADE\_ST** Cross Street: **WALNUT\_AVE** Location: **NE**

ADA ID: **RPRK211223112529** Ramp Type: **Type 1 - Perpendicular Diagonal Initial Pass/Fail: Fail** Overall Compliance: **No** Severity Score: **15**

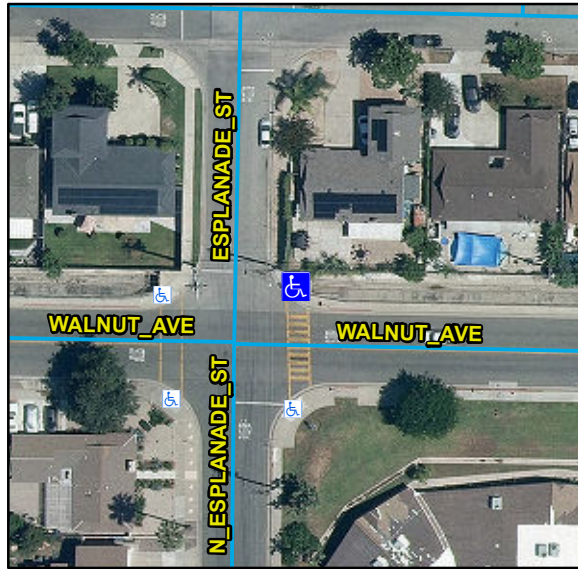
| Compliance | Description | Data | Compliance | Description | Data |
|---|---|---|---|---|---|
| <b>No</b> | Ramp Run Slope (%) | <b>11.4</b> | <b>N/A</b> | Flare Slope LT (%) | <b>N/A</b> |
| <b>No</b> | Gutter Lip Height (in) | <b>0.25</b> | | Road Run Slope (%) | <b>0.5</b> |

**Remove & Replace Curb Ramp With Two New Directional Ramps or Equivalent. Grind Gutter Lip.**

**R304.2.2, R302.7.2, STD 1115**
