# Access Compliance Report Public Rights-of-Way (Curb Ramps)

Main Street: WALNUT\_AVE Cross Street: N\_ESPLANADE\_ST Location: SE

ADA ID: RPRK211223112713 Ramp Type: Type 1 - Perpendicular Diagonal Initial Pass/Fail: Fail Overall Compliance: No Severity Score: 16

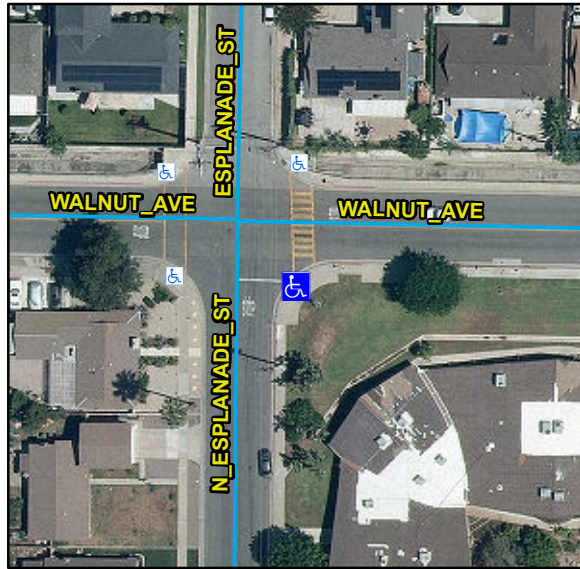
| Compliance | Description | Data | Compliance | Description | Data |
|---|---|---|---|---|---|
| No | Ramp Run Slope (%) | 10.1 | N/A | Flare Slope LT (%) | N/A |
| No | Ramp Cross Slope (%) | 2.8 | N/A | Flare Traversable LT | N/A |
| No | Gutter Lip Height (in) | 0.25 | | Road Run Slope (%) | 0.5 |

Remove & Replace Curb Ramp With Two New Directional Ramps or Equivalent. Grind Gutter Lip.

R304.2.2, R304.5.3, R302.7.2, STD 1115
