# Access Compliance Report Public Rights-of-Way (Curb Ramps)

Main Street: N\_ESPLANADE\_ST Cross Street: WALNUT\_AVE Location: SW

ADA ID: RPRK211223113000 Ramp Type: Type 1 - Perpendicular Diagonal Initial Pass/Fail: Fail Overall Compliance: No Severity Score: 16

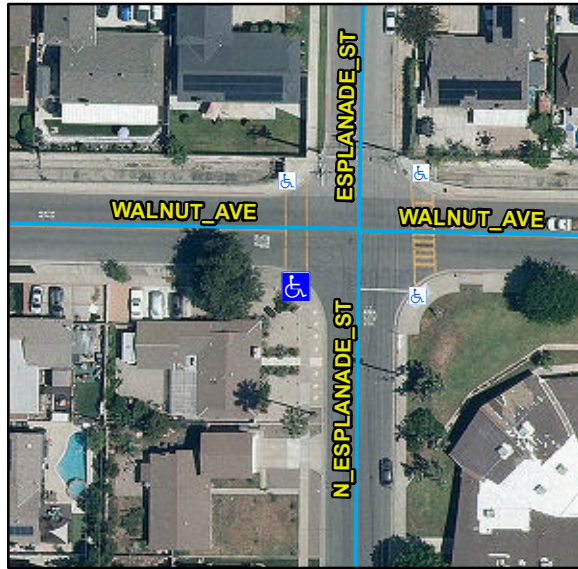
| Compliance | Description | Data | Compliance | Description | Data |
|---|---|---|---|---|---|
| No | Ramp Run Slope (%) | 10.4 | N/A | Flare Slope LT (%) | N/A |
| No | Gutter Lip Height (in) | 0.25 | | Road Run Slope (%) | 0.2 |

**Remove & Replace Curb Ramp With Two New Directional Ramps or Equivalent. Grind Gutter Lip.**

R304.2.2, R302.7.2, STD 1115
