# Access Compliance Report

## Public Rights-of-Way

### (Curb Ramps)

Main Street: WALNUT\_AVE Cross Street: ESPLANADE\_ST Location: NE

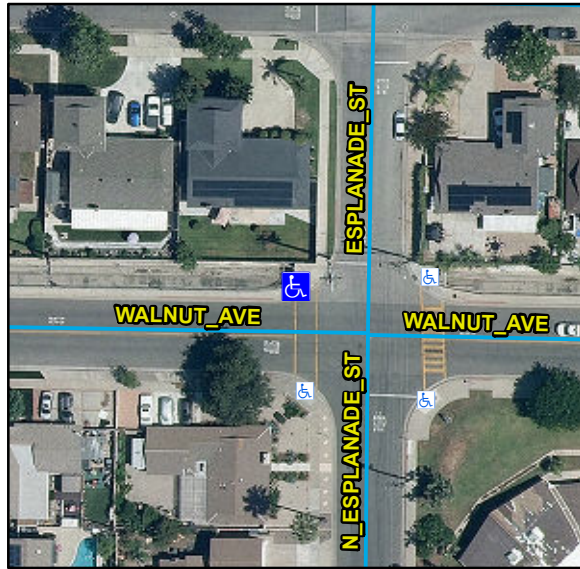
ADA ID: RPRK211223113200 Ramp Type: Type 1 - Perpendicular Diagonal Initial Pass/Fail: Fail Overall Compliance: No Severity Score: 15

| Compliance | Description | Data | Compliance | Description | Data |
|---|---|---|---|---|---|
| No | Ramp Run Slope (%) | 11.1 | N/A | Flare Slope LT (%) | N/A |

**Remove & Replace Curb Ramp With Two New Directional Ramps or Equivalent.**

**R304.2.2, STD 1115**
