# Access Compliance Report Public Rights-of-Way (Curb Ramps)

Main Street: E\_SYCAMORE\_AVE Cross Street: HEWES\_ST Location: NW

ADA ID: RPRK211223113710 Ramp Type: Type 1 - Perpendicular Diagonal Initial Pass/Fail: Fail Overall Compliance: No Severity Score: 15

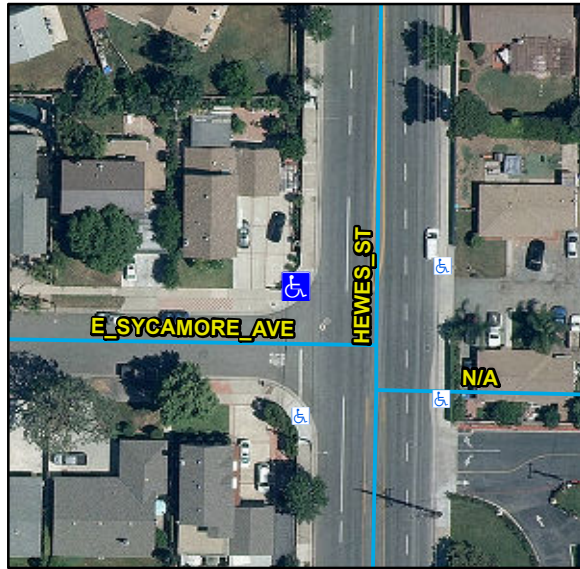
| Compliance | Description | Data | Compliance | Description | Data |
|---|---|---|---|---|---|
| No | Ramp Cross Slope (%) | 5.3 | N/A | Flare Traversable LT | N/A |

**Remove & Replace Curb Ramp With Two New Directional Ramps or Equivalent.**

**R304.5.3, STD 1115**
