# Access Compliance Report

## Public Rights-of-Way

### (Curb Ramps)

Main Street: HEWES\_ST Cross Street: E\_SILVERLEAF\_AVE Location: NE

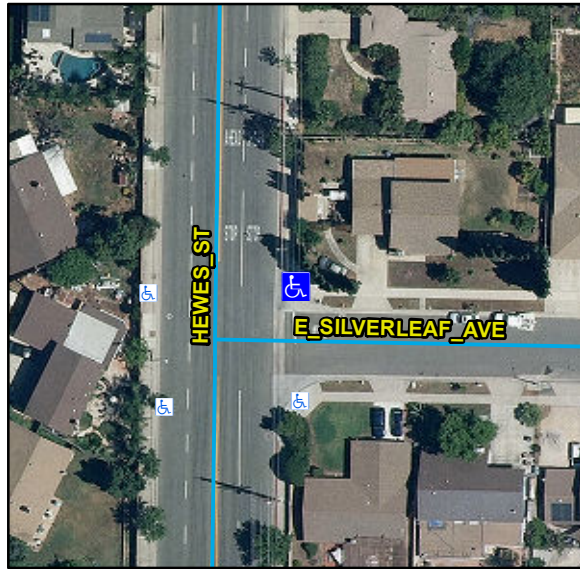
ADA ID: RPRK211223113914 Ramp Type: Type 1 - Perpendicular Diagonal Initial Pass/Fail: Pass Overall Compliance: No Severity Score: 0

| Compliance | Description | Data | Compliance | Description | Data |
|---|---|---|---|---|---|
| N/A | Landing Movement Obstructed? | Yes | Yes | DWS Contrast | Yes |
| | Landing Movement Type | Curb | Yes | DWS Length (in) | 36 |

Remove & Replace Landing.

R304.2.1, STD 1115

\$ 531
