# Access Compliance Report Public Rights-of-Way (Curb Ramps)

Main Street: HEWES\_ST Cross Street: E\_SPRING\_ST Location: SW

ADA ID: RPRK211223115345 Ramp Type: Type 1 - Perpendicular Diagonal Initial Pass/Fail: Pass Overall Compliance: No Severity Score: 9

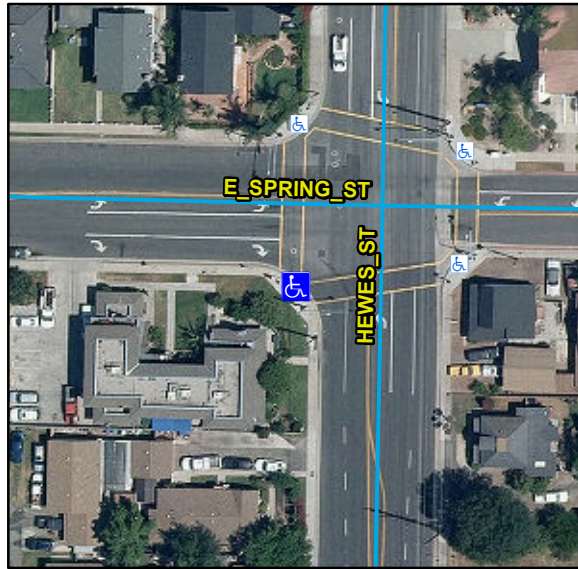
R304.2.1, R304.5.4, R304.5.3, STD 1115

| Compliance | Description | Data | Compliance | Description | Data |
|---|---|---|---|---|---|
| No | Gutter Run Slope (%) | 10.6 | | Road Cross Slope (%) | 4.3 |
| No | Gutter Cross Slope (%) | 2.1 | | | |

Remove & Replace Landing. Remove & Replace Gutter.
