# Access Compliance Report Public Rights-of-Way (Curb Ramps)

Main Street: S\_ESPLANADE\_ST Cross Street: SPRING\_ST Location: SW

ADA ID: RPRK211223115927 Ramp Type: Type 4 - Parallel Initial Pass/Fail: Fail Overall Compliance: No Severity Score: 2

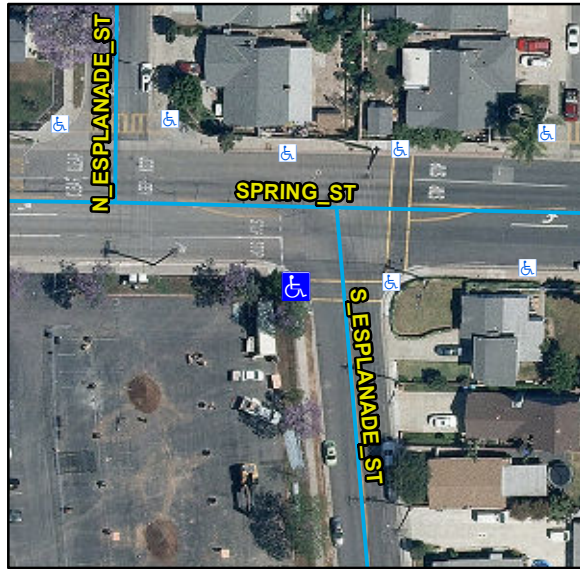
| Compliance | Description | Data | Compliance | Description | Data |
|---|---|---|---|---|---|
| Yes | Ramp Cross Slope LT (%) | 1.6 | No | Ramp Cross Slope RT (%) | 2.9 |

**Remove & Replace Curb Ramp With Two New Directional Ramps or Equivalent.**

**R304.5.3, STD 1115**
