# Access Compliance Report Public Rights-of-Way (Curb Ramps)

Main Street: E\_SPRING\_ST Cross Street: N\_EARLHAM\_ST Location: NW

ADA ID: RPRK211223120611 Ramp Type: Type 1 - Perpendicular Diagonal Initial Pass/Fail: Fail Overall Compliance: No Severity Score: 30

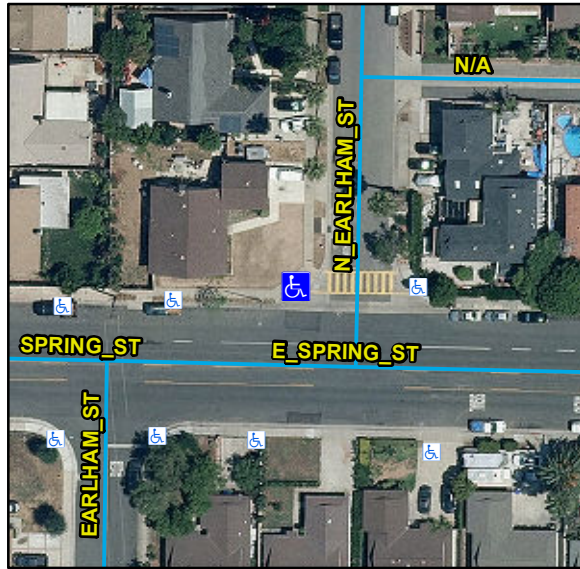
| Compliance | Description | Data | Compliance | Description | Data |
|---|---|---|---|---|---|
| No | Ramp Run Slope (%) | 10.8 | N/A | Flare Slope LT (%) | N/A |
| No | Ramp Cross Slope (%) | 5.3 | N/A | Flare Traversable LT | N/A |
| No | Gutter Lip Height (in) | 0.25 | | Road Run Slope (%) | 1.7 |

Remove & Replace Curb Ramp With Two New Directional Ramps or Equivalent. Grind Gutter Lip.

R204.3, R304.2.2, R304.5.3, R302.7.2, STD 1115
