# Access Compliance Report Public Rights-of-Way (Curb Ramps)

Main Street: N\_EARLHAM\_ST Cross Street: E\_SPRING\_ST Location: NE

ADA ID: RPRK211223121003 Ramp Type: Type 4 - Parallel Initial Pass/Fail: Fail Overall Compliance: No Severity Score: 30

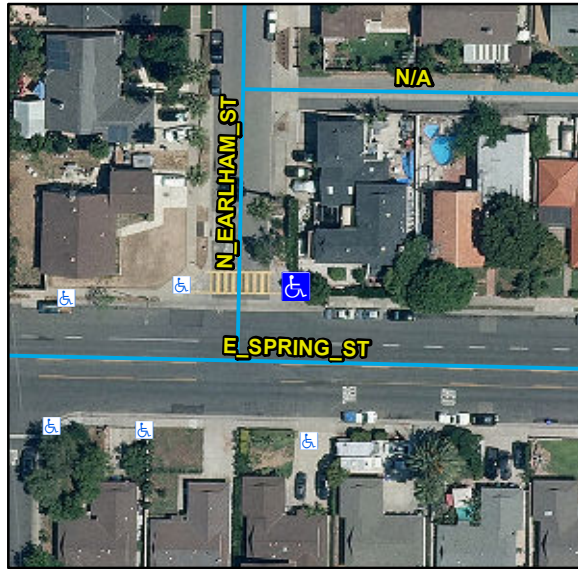
| Compliance | Description | Data | Compliance | Description | Data |
|---|---|---|---|---|---|
| No | Ramp Run Slope LT (%) | 8.7 | Yes | Ramp Run Slope RT (%) | 6.6 |
| No | Ramp Cross Slope LT (%) | 4.6 | No | Ramp Cross Slope RT (%) | 6.4 |

**Remove & Replace Curb Ramp With Two New Directional Ramps or Equivalent.**

**R304.3.2, R304.5.3, STD 1115**
