# Access Compliance Report Public Rights-of-Way (Curb Ramps)

Main Street: E\_AVENIDA\_PALMAR Cross Street: RANCHO\_SANTIAGO\_BLVD Location: SE

ADA ID: RPRK211223122444 Ramp Type: Type 4 - Parallel Initial Pass/Fail: Fail Overall Compliance: No Severity Score: 2

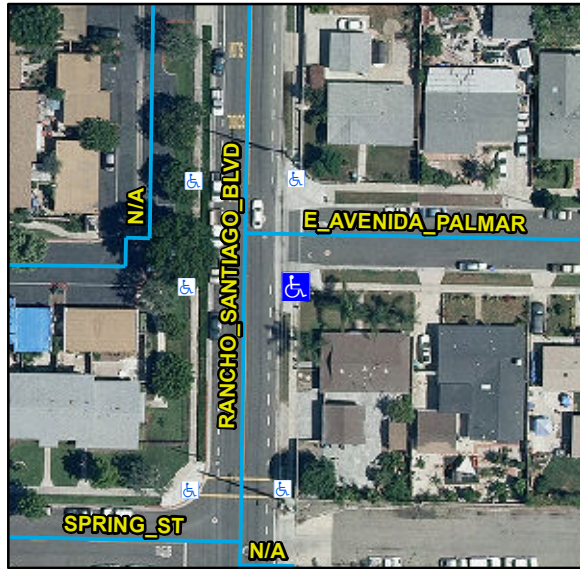
| Compliance | Description | Data | Compliance | Description | Data |
|---|---|---|---|---|---|
| No | Ramp Cross Slope LT (%) | 2.7 | Yes | Ramp Cross Slope RT (%) | 1.2 |

Remove & Replace Curb Ramp With Two New Directional Ramps or Equivalent.

R304.5.3, STD 1115
