# Access Compliance Report Public Rights-of-Way (Curb Ramps)

Main Street: RANCHO\_SANTIAGO\_BLV Cross Street: N/A Location: NE

ADA ID: RPRK211223122655 Ramp Type: Type 1 - Perpendicular Initial Pass/Fail: Pass Overall Compliance: No Severity Score: 24

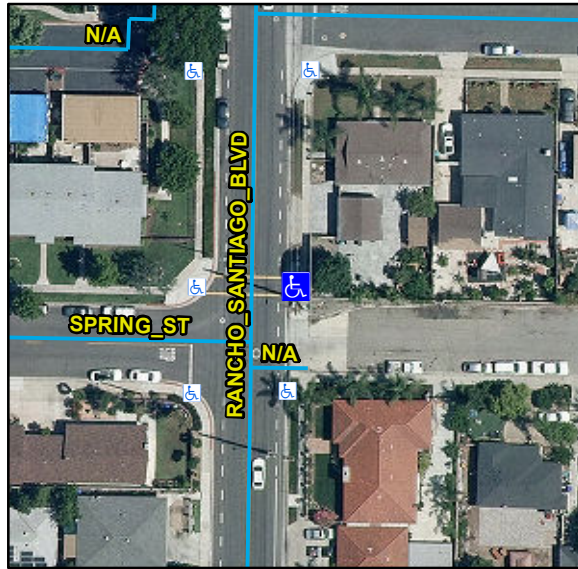
| Compliance | Description | Data | Compliance | Description | Data |
|---|---|---|---|---|---|
| No | Landing Run Slope (%) | 4.7 | N/A | Flare Traversable RT | No |
| No | Gutter Run Slope (%) | 5.2 | | Road Cross Slope (%) | N/A |
| No | Overall Surface Condition: | Poor | Yes | Perp Joint Present | Yes |

Remove & Replace Entire Ramp. Remove & Replace Gutter. Utility Present.
