# Access Compliance Report Public Rights-of-Way (Curb Ramps)

Main Street: E\_SPRING\_ST Cross Street: N/A Location: NW

ADA ID: RPRK211223123326 Ramp Type: Type 4 - Parallel Initial Pass/Fail: Pass Overall Compliance: No Severity Score: 0

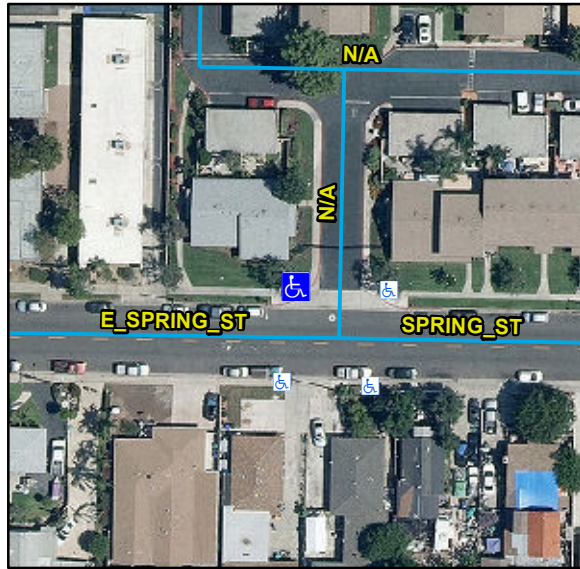
Surveyor Notes:

**Ponding in Landing**

OC Std/PROW:

**R204.3, STD 1115**

Possible Solutions:

**Remove & Replace Curb Ramp With Two New Directional Ramps or Equivalent.**

Total Cost: \$ 4000
