# Access Compliance Report Public Rights-of-Way (Curb Ramps)

Main Street: N/A Cross Street: SPRING\_ST Location: NE

ADA ID: RPRK211223123653 Ramp Type: Type 4 - Parallel Initial Pass/Fail: Pass Overall Compliance: No Severity Score: 0

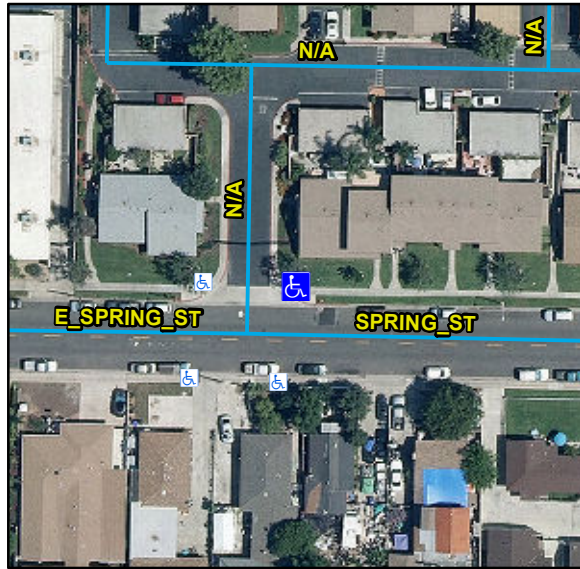
| Compliance | Description | Data | Compliance | Description | Data |
|---|---|---|---|---|---|
| Yes | Gutter Cross Slope (%) | 0.1 | No | Perpendicular Joint Present | No |

Possible Solutions:

**Remove & Replace Curb Ramp With Two New Directional Ramps or Equivalent.**

**R204.3, STD 1115**
