# Access Compliance Report Public Rights-of-Way (Curb Ramps)

Main Street: **SPRING\_ST** Cross Street: **N/A** Location: **NW**

ADA ID: **RPRK211223123956** Ramp Type: **Type 4 - Parallel** Initial Pass/Fail: **Pass** Overall Compliance: **No** Severity Score: **0**

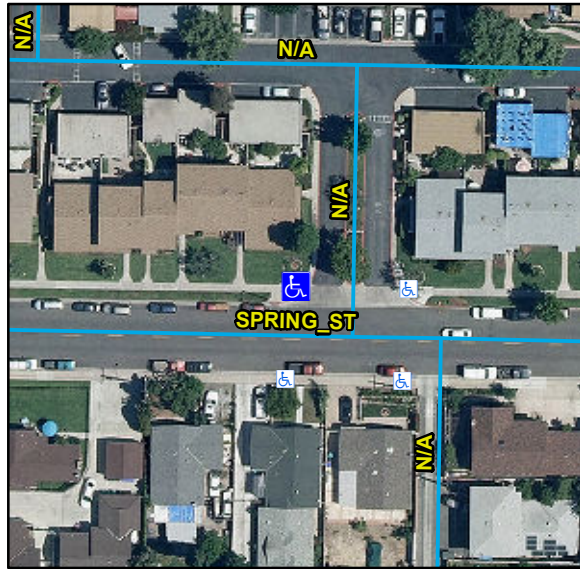
| Compliance | Description | Data | Compliance | Description | Data |
|---|---|---|---|---|---|
| <b>Yes</b> | Gutter Cross Slope (%) | <b>0.3</b> | <b>No</b> | Perpendicular Joint Present | <b>No</b> |

**Remove & Replace Curb Ramp With Two New Directional Ramps or Equivalent.**
