# Access Compliance Report Public Rights-of-Way (Curb Ramps)

| Main Street: N/A | | Cross Street: SPRING_ST | | Location: | NE |
| ADA ID: RPRK211223124403 | Ramp Type: Type 4 - Parallel | Initial Pass/Fail: Fail | Overall Compliance: No | Severity Score: | 15 |

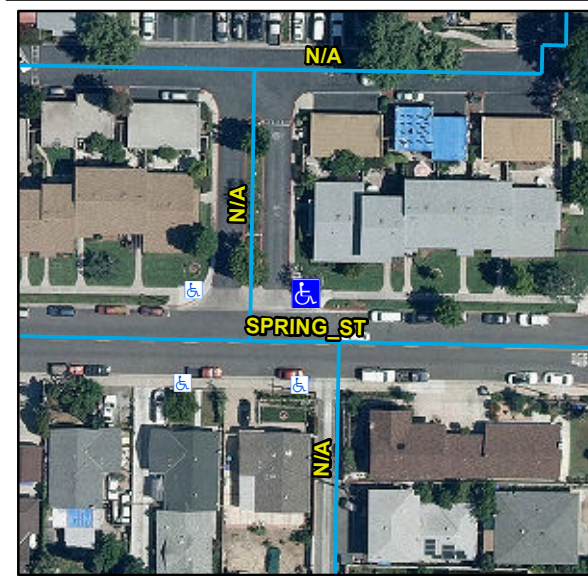
| Compliance | Description | Data | Compliance | Description | Data |
|---|---|---|---|---|---|
| No | Ramp Run Slope LT (%) | 8.8 | Yes | Ramp Run Slope RT (%) | 5.4 |

**Remove & Replace Curb Ramp With Two New Directional Ramps or Equivalent.**

**R304.3.2, STD 1115**

Total Cost: \$ 4000
