## **Access Compliance Report Public Rights-of-Way** (Curb Ramps)

Main Street: CHAPMAN AVE **Cross Street: RANCHO SANTIAGO BLVD** Location: NW

ADA ID: RPRK211223125852 Ramp Type: Type 4 - Parallel **Initial Pass/Fail: Pass Overall Compliance: No Severity Score:**

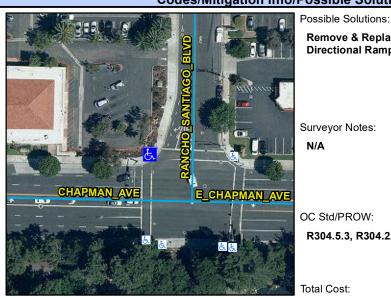
Field Measurements/Component Compliance								
Coi		npliance Description		Compliance Description		Data		
New	N/A	Ramp Length LT (in)	66	N/A	Ramp Length RT (in)	62		
Present.	Yes	Ramp Width LT (in)	85	Yes	Ramp Width RT (in)	85		
	Yes	Ramp Run Slope LT (%)	2.8	Yes	Ramp Run Slope RT (%)	7.3		
	No	Ramp Cross Slope LT (%)	3.5	No	Ramp Cross Slope RT (%)	3.2		
	N/A	Landing Present	Yes	Yes	DWS Provided	Yes		
	N/A	Landing Length (in)	85	Yes	DWS Contrast	Yes		
	Yes	Landing Width (in)	48	Yes	DWS Length (in)	36		
	No	Landing Run Slope (%)	2.5	Yes	DWS Full Width	Yes		
	No	Landing Cross Slope (%)	2.6		DWS Offset Type	Single		
	N/A	Landing Movement Obstructed?	No	Yes	DWS Offset Left (in)	0		
		Landing Movement Type	Curb	Yes	DWS Offset Right (in)	N/A		
STD 1115	N/A	Landing Shared	No					
	Yes	Clear Space	Yes					
	Yes	Clear Space To Crosswalk (in)	48					
\$ 4000	N/A	Marked Crosswalk 1	Yes	N/A	Marked Crosswalk 2	Yes		
		Crossing 1 Direction	S		Crossing 2 Direction	E

Remove & Replace Curb Ramp With Two New Directional Ramps or Equivalent. Utility Present.

R304.5.3, R304.2.2-Perp, R304.3.2-Para, STD 1115
