# Access Compliance Report Public Rights-of-Way (Curb Ramps)

Main Street: E\_CENTER\_ST Cross Street: HEWES\_ST Location: SW

ADA ID: RPRK211223131327 Ramp Type: Type 1 - Perpendicular Initial Pass/Fail: Fail Overall Compliance: No Severity Score: 15

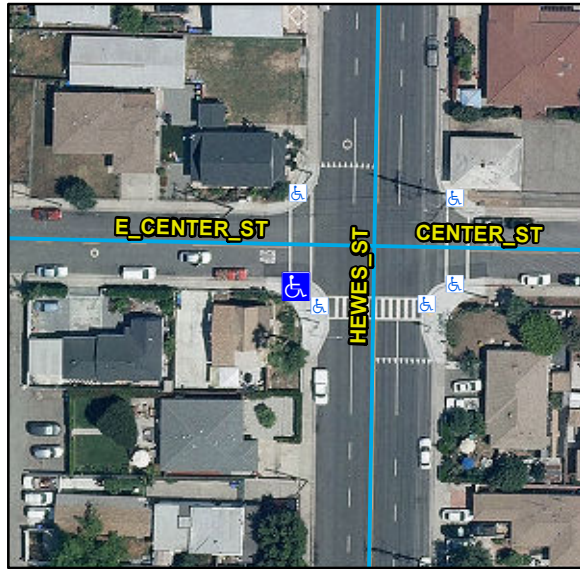
| Compliance | Description | Data | Compliance | Description | Data |
|---|---|---|---|---|---|
| No | Ramp Run Slope (%) | 8.8 | N/A | Flare Slope LT (%) | N/A |

Remove & Replace Entire Ramp.
