# Access Compliance Report Public Rights-of-Way (Curb Ramps)

Main Street: HEWES\_ST Cross Street: E\_CENTER\_ST Location: SW

ADA ID: RPRK211223131437 Ramp Type: Type 1 - Perpendicular Initial Pass/Fail: Pass Overall Compliance: Yes Severity Score: 0

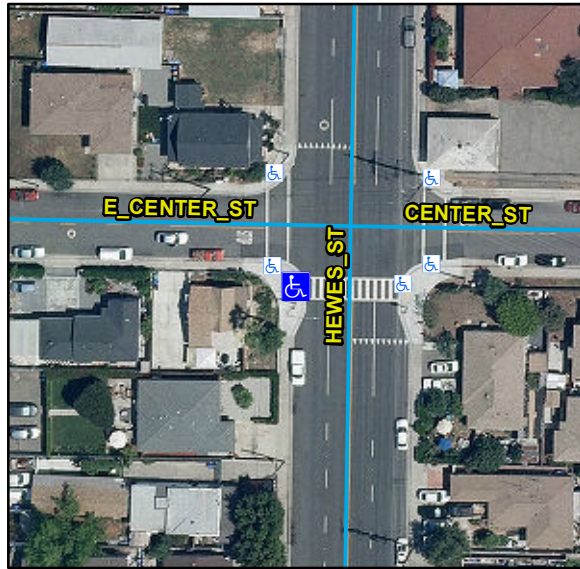
Parcel ID Number 093-112-47  
Ramp Island Or Median None  
Ramp Orientation NonDiag  
Google Street View Link:

Possible Solutions:

N/A
