# Access Compliance Report

## Public Rights-of-Way

### (Curb Ramps)

Main Street: CENTER\_ST Cross Street: HEWES\_ST Location: SE

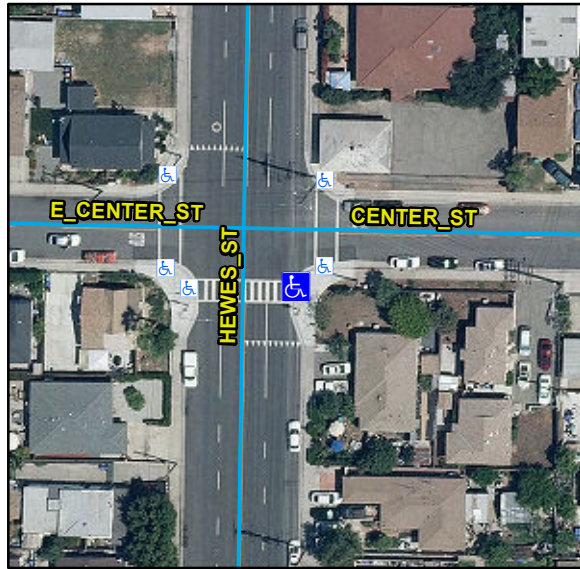
ADA ID: RPRK211223131705 Ramp Type: Type 1 - Perpendicular Initial Pass/Fail: Pass Overall Compliance: No Severity Score: 0

| Compliance | Description | Data | Compliance | Description | Data |
|---|---|---|---|---|---|
| No | Landing Cross Slope (%) | 2.3 | Yes | DWS Provided | Yes |

Remove & Replace Landing.

R304.5.3, STD 1115

\$ 531
