# Access Compliance Report Public Rights-of-Way (Curb Ramps)

Main Street: HEWES\_ST Cross Street: E\_CHAPMAN\_AVE Location: NE

ADA ID: RPRK211223132359 Ramp Type: Type 1 - Perpendicular Initial Pass/Fail: Fail Overall Compliance: No Severity Score: 16

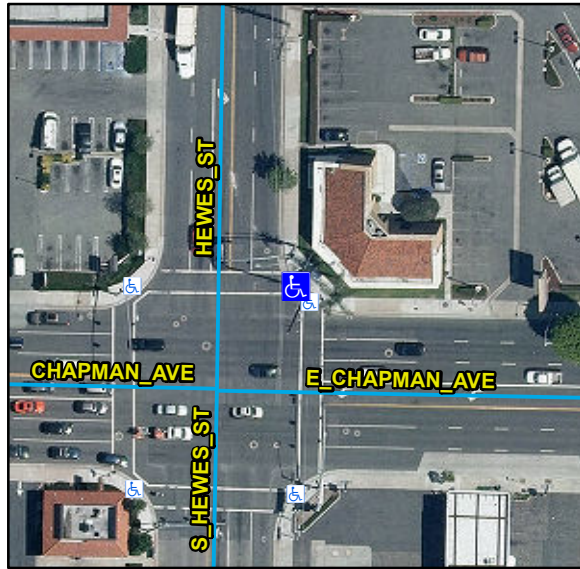
| Compliance | Description | Data | Compliance | Description | Data |
|---|---|---|---|---|---|
| No | Ramp Run Slope (%) | 8.8 | N/A | Flare Slope LT (%) | N/A |

Remove & Replace Entire Ramp.

R304.2.2, STD 1115
