# Access Compliance Report Public Rights-of-Way (Curb Ramps)

Main Street: E\_CHAPMAN\_AVE Cross Street: HEWES\_ST Location: NE

ADA ID: RPRK211223132536 Ramp Type: Type 1 - Perpendicular Initial Pass/Fail: Pass Overall Compliance: No Severity Score: 2

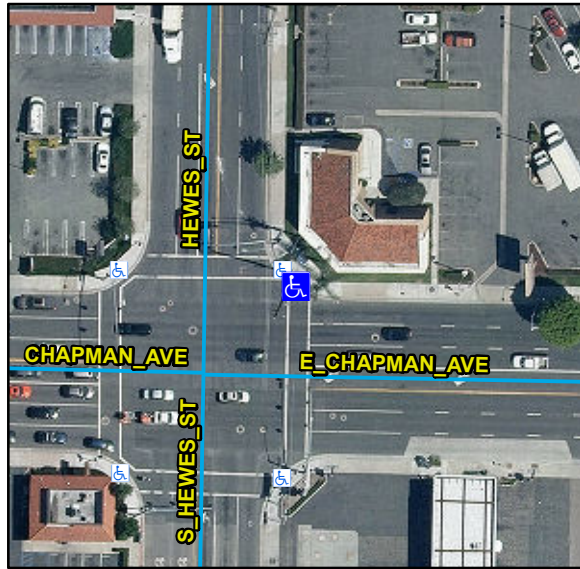
Remove & Replace Landing. Gutter Ponding Observed. Utility Present.

| Compliance | Description | Data | Compliance | Description | Data |
|---|---|---|---|---|---|
| No | Landing Cross Slope (%) | 2.1 | Yes | DWS Provided | Yes |
| No | Gutter Ponding | Yes | Yes | Curb Slope | 2.7 |

R304.2.1, R304.5.3, R302.7, STD 1115
