# Access Compliance Report Public Rights-of-Way (Curb Ramps)

Main Street: E\_CHAPMAN\_AVE Cross Street: ESPLANADE\_ST Location: SE

ADA ID: RPRK211223133726 Ramp Type: Type 1 - Perpendicular Diagonal Initial Pass/Fail: Pass Overall Compliance: No Severity Score: 12

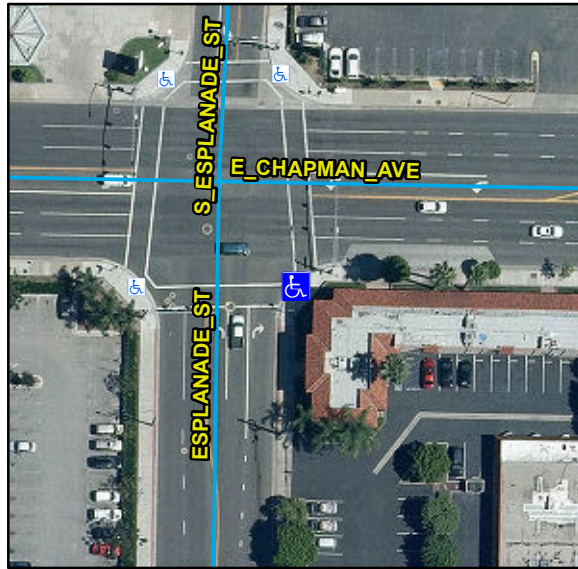
| Compliance | Description | Data | Compliance | Description | Data |
|---|---|---|---|---|---|
| No | Gutter Ponding | Yes | Yes | Curb Slope | 1.3 |
| No | Gutter Lip Height (in) | 1 | | Road Run Slope (%) | 0.2 |

Remove & Replace Landing. Grind Gutter Lip.
