# Access Compliance Report Public Rights-of-Way (Curb Ramps)

Main Street: CAMBERA\_LN Cross Street: BIMINI\_DR Location: N

ADA ID: RPRK211228134528 Ramp Type: Type 1 - Perpendicular Diagonal Initial Pass/Fail: Pass Overall Compliance: No Severity Score: 16

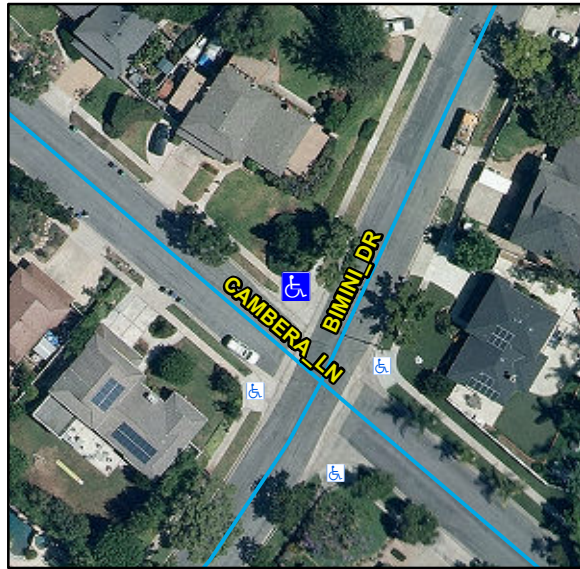
| Compliance | Description | Data | Compliance | Description | Data |
|---|---|---|---|---|---|
| Yes | Landing Cross Slope (%) | 0.3 | No | DWS Provided | No |

Remove & Replace Curb Ramp With Two New Directional Ramps or Equivalent.

R304.2.1, R305, STD 1115
