# Access Compliance Report Public Rights-of-Way (Curb Ramps)

| Main Street: HYDE_PARK_DR | | Cross Street: ARROYO_AVE | | Location: | N |
| ADA ID: RPRK211228135830 | Ramp Type: Type 4 - Parallel | Initial Pass/Fail: Fail | Overall Compliance: No | Severity Score: | 16 |

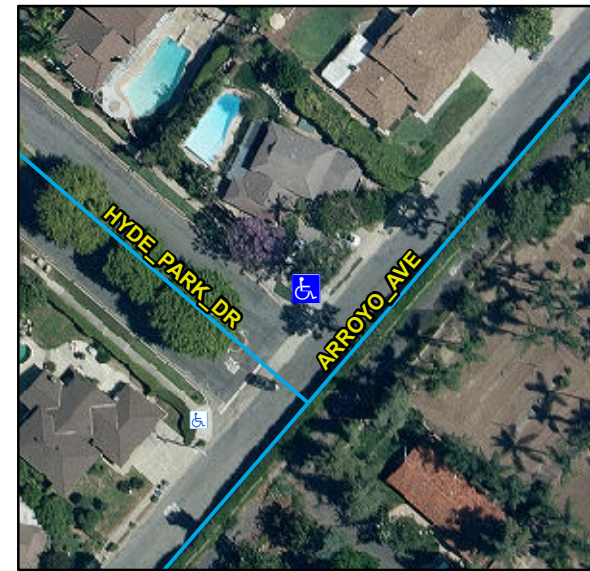
| Compliance | Description | Data | Compliance | Description | Data |
|---|---|---|---|---|---|
| Yes | Ramp Run Slope LT (%) | 1.4 | No | Ramp Run Slope RT (%) | 11.3 |
| No | Ramp Cross Slope LT (%) | 2.6 | Yes | Ramp Cross Slope RT (%) | 0.3 |

**Remove & Replace Curb Ramp With Two New Directional Ramps or Equivalent.**

**R304.5.3, R304.3.2, STD 1115**

Total Cost: \$ 4000
