# Access Compliance Report Public Rights-of-Way (Curb Ramps)

| Main Street: RAVENCREST_RD | | Cross Street: NEWPORT_AVE | | Location: | S |
| ADA ID: RPRK211228150131 | Ramp Type: Type 4 - Parallel | Initial Pass/Fail: Fail | Overall Compliance: No | Severity Score: | 2 |

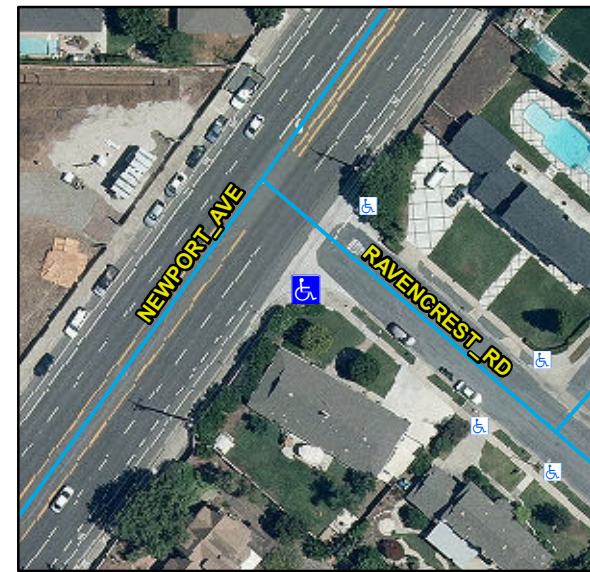
| Compliance | Description | Data | Compliance | Description | Data |
|---|---|---|---|---|---|
| No | Ramp Cross Slope LT (%) | 2.5 | Yes | Ramp Cross Slope RT (%) | 1.8 |

**Remove & Replace Curb Ramp With Two New Directional Ramps or Equivalent.**

**R304.5.3, STD 1115**

Total Cost: \$ 4000
