# Access Compliance Report Public Rights-of-Way (Curb Ramps)

Main Street: CAMERON\_LN Cross Street: VANDERLIP\_AVE Location: NE

ADA ID: RPRK211228173335 Ramp Type: Type 4 - Parallel Initial Pass/Fail: Fail Overall Compliance: No Severity Score: 15

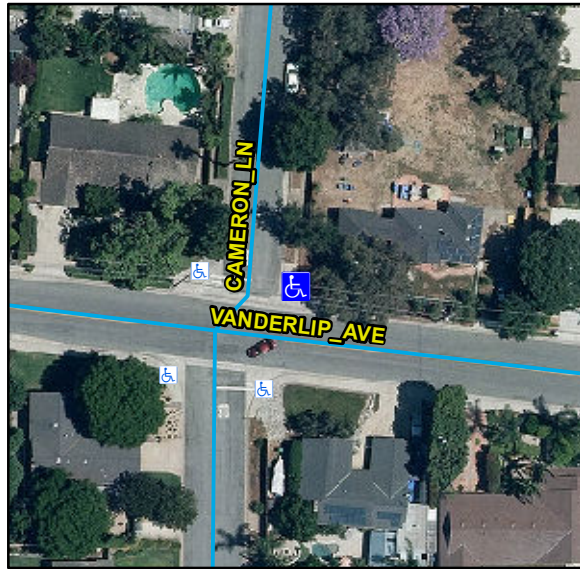
| Compliance | Description | Data | Compliance | Description | Data |
|---|---|---|---|---|---|
| No | Ramp Run Slope LT (%) | 9.3 | No | Ramp Run Slope RT (%) | 9.6 |

**Remove & Replace Curb Ramp With Two New Directional Ramps or Equivalent.**

**R204.3, R304.3.2, STD 1115**
