# Access Compliance Report Public Rights-of-Way (Curb Ramps)

Main Street: FOWLER\_AVE Cross Street: KINGSVIEW\_RD Location: NW

ADA ID: RPRK211229115828 Ramp Type: Type 4 - Parallel Initial Pass/Fail: Fail Overall Compliance: No Severity Score: 60

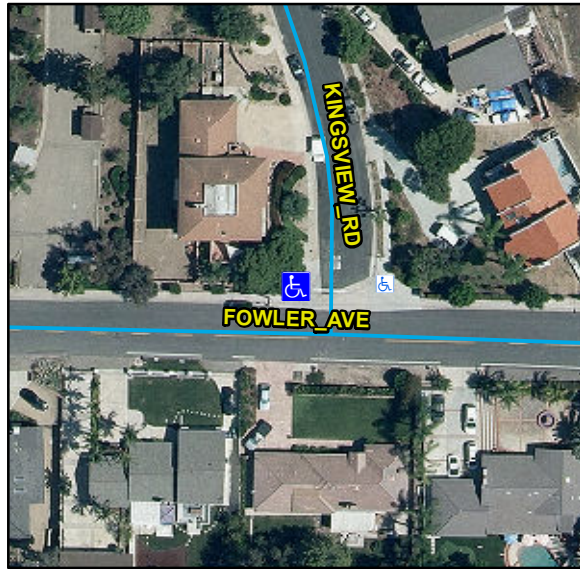
| Compliance | Description | Data | Compliance | Description | Data |
|---|---|---|---|---|---|
| No | Ramp Run Slope LT (%) | 11.9 | No | Ramp Run Slope RT (%) | 12.5 |
| No | Ramp Cross Slope LT (%) | 7.8 | Yes | Ramp Cross Slope RT (%) | 1.2 |

**Remove & Replace Curb Ramp With Two New Directional Ramps or Equivalent.**

**R304.3.2, R304.5.3, STD 1115**

Total Cost: \$ 4000
