# Access Compliance Report Public Rights-of-Way (Curb Ramps)

Main Street: S\_NEWHAVEN\_DR Cross Street: E\_KIRKWOOD\_AVE Location: SW

ADA ID: RPRK211229123729 Ramp Type: Type 4 - Parallel Initial Pass/Fail: Fail Overall Compliance: No Severity Score: 16

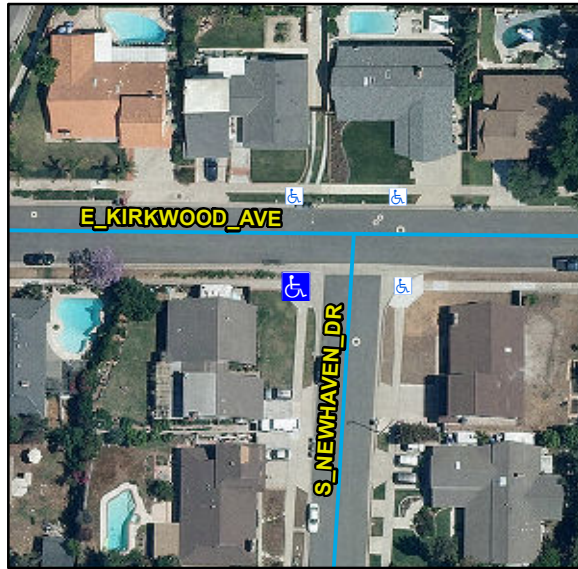
| Compliance | Description | Data | Compliance | Description | Data |
|---|---|---|---|---|---|
| No | Ramp Run Slope LT (%) | 10.8 | Yes | Ramp Run Slope RT (%) | 0.2 |
| No | Ramp Cross Slope LT (%) | 2.9 | No | Ramp Cross Slope RT (%) | 3.5 |

Remove & Replace Curb Ramp With Two New Directional Ramps or Equivalent. Replace Spandrel.
