# Access Compliance Report Public Rights-of-Way (Curb Ramps)

Main Street: ESPLANADE\_ST Cross Street: E\_FAIRHAVEN\_AVE Location: NE

ADA ID: RPRK211229130735 Ramp Type: Type 4 - Parallel Initial Pass/Fail: Fail Overall Compliance: No Severity Score: 16

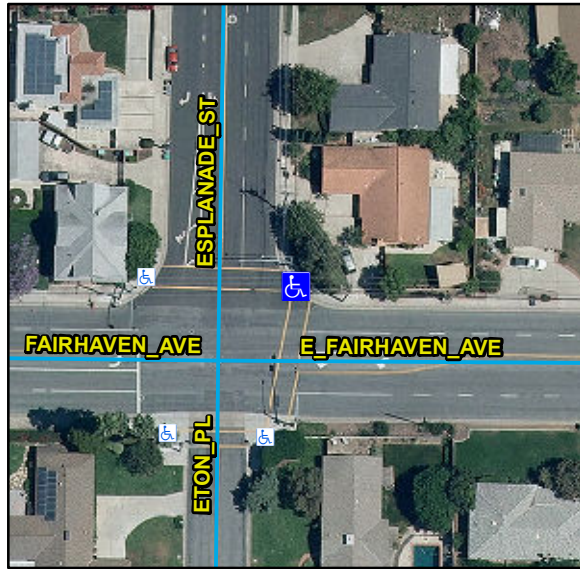
| Compliance | Description | Data | Compliance | Description | Data |
|---|---|---|---|---|---|
| Yes | Ramp Run Slope LT (%) | 2.2 | No | Ramp Run Slope RT (%) | 8.5 |
| No | Ramp Cross Slope LT (%) | 2.4 | Yes | Ramp Cross Slope RT (%) | 1.2 |

Remove & Replace Curb Ramp With Two New Directional Ramps or Equivalent.

R304.5.3, R304.3.2, STD 1115
