Access Compliance Report Public Rights-of-Way (Curb Ramps)

Main Street: S_CEDARWOOD_ST Cross Street: FAIRHAVEN_AVE Location: NE

ADA ID: RPRK211229133216 Ramp Type: Type 4 - Parallel Initial Pass/Fail: Pass Overall Compliance: Yes Severity Score:

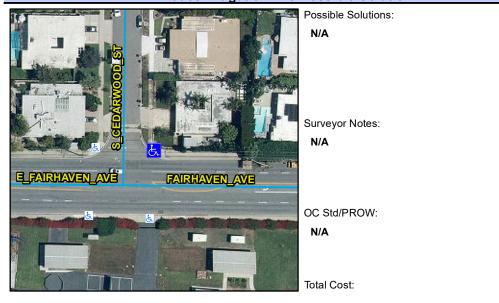
Field Measurements/Component Compliance									
	Compliance Description		Data	Compliance Description		Description	Data		
	N/A	Ramp Length LT (in)	112	N/A	Ramp Lo	ength RT (in)	120		
	Yes	Ramp Width LT (in)	80	Yes	Ramp W	/idth RT (in)	80		
	Yes	Ramp Run Slope LT (%)	3.6	Yes	Ramp R	un Slope RT (%)	6.3		
	Yes	Ramp Cross Slope LT (%)	0.2	Yes	Ramp C	ross Slope RT (%)	0.1		
	N/A	Landing Present	Yes	Yes	DWS Pr	ovided	Yes		
	N/A	Landing Length (in)	80	Yes	DWS Co	ontrast	Yes		
	Yes	Landing Width (in)	48	Yes	DWS Le	ngth (in)	36		
	Yes	Landing Run Slope (%)	0	Yes	DWS Fu	ıll Width	Yes		
	Yes	Landing Cross Slope (%)	0.5		DWS Of	fset Type	Single		
	N/A	Landing Movement Obstructed?	No	Yes	DWS Of	fset Left (in)	0		
		Landing Movement Type	Curb	Yes	DWS Of	fset Right (in)	N/A		
	N/A	Landing Shared	No						
	N/A	Clear Space	Yes						
	N/A	Clear Space To Crosswalk (in)	48						
0	N/A	Marked Crosswalk 1	No	N/A	Marked	Crosswalk 2	No

Crossing 1 Direction	W		Crossing	g 2 Direction	s		
Т		Marked Crosswalk 1 Width (in)	N/A		Marked	Crosswalk 2 Width (in)	N/A		
n	N/A	Ramp Inside Crosswalk 1	N/A	N/A	Ramp In	side Crosswalk 2	N/A		
Ε		Crossing 1 Slope (%)	0.6		Crossing	g 2 Slope (%)	3.4		
ol		Crossing 1 Cross Slope (%)	1.4		Crossing	g 2 Cross Slope (%)	0.5		
	Yes	Gutter Ponding	No	Yes	Curb Slo	ppe	2.1		
	Yes	Gutter Lip Height (in)	0		Road Ru	un Slope (%)	1.1		
_	Yes	Gutter Run Slope (%)	2.4		Road Cr	oss Slope (%)	2		
a	Yes	Gutter Cross Slope (%)	8.0	Yes	Perpend	licular Joint Present	Yes		
0	Yes	s Overall Surface Condition Acceptable							
		Cross Gutter Present?	No		Spandre	el Present?	No		
Α		Replace Cross Gutter?	N/A		Replace	e Spandrel?	N/A
