# Access Compliance Report Public Rights-of-Way (Curb Ramps)

**Main Street:** DARMEL\_PL      **Cross Street:** DARMEL\_PL      **Location:** NW

**ADA ID:** RPRK211229134734      **Ramp Type:** Type 4 - Parallel      **Initial Pass/Fail:** Pass      **Overall Compliance:** No      **Severity Score:** 0

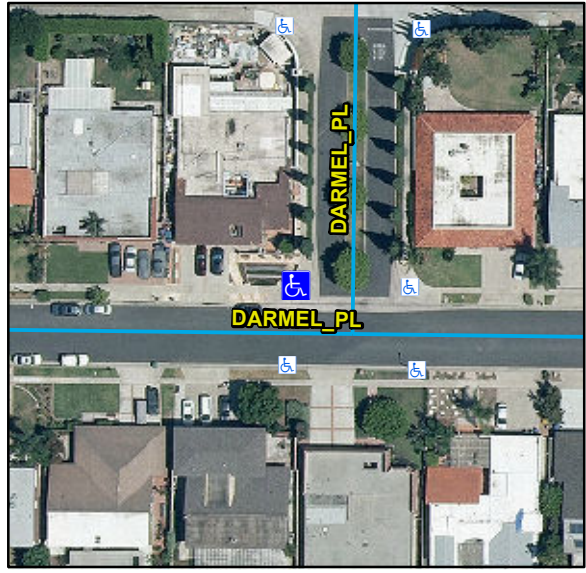
Compliance	Description	Data	Compliance	Description	Data
N/A	Ramp Length LT (in)	112	N/A	Ramp Length RT (in)	114
Yes	Ramp Width LT (in)	92	Yes	Ramp Width RT (in)	92
Yes	Ramp Run Slope LT (%)	3.2	Yes	Ramp Run Slope RT (%)	5.6
Yes	Ramp Cross Slope LT (%)	1.4	Yes	Ramp Cross Slope RT (%)	1.8
N/A	Landing Present	Yes	Yes	DWS Provided	Yes
N/A	Landing Length (in)	92	Yes	DWS Contrast	Yes
Yes	Landing Width (in)	48	Yes	DWS Length (in)	36
Yes	Landing Run Slope (%)	1.8	Yes	DWS Full Width	Yes
Yes	Landing Cross Slope (%)	0.8		DWS Offset Type	Single
N/A	Landing Movement Obstructed?	No	Yes	DWS Offset Left (in)	0
	Landing Movement Type	Curb	Yes	DWS Offset Right (in)	N/A
N/A	Landing Shared	No			
N/A	Clear Space	Yes			
N/A	Clear Space To Crosswalk (in)	48			
N/A	Marked Crosswalk 1	No	N/A	Marked Crosswalk 2	No
	Crossing 1 Direction	S		Crossing 2 Direction	E
	Marked Crosswalk 1 Width (in)	N/A		Marked Crosswalk 2 Width (in)	N/A
N/A	Ramp Inside Crosswalk 1	N/A	N/A	Ramp Inside Crosswalk 2	N/A

Crossing 1 Slope (%)	2.2		Crossing 2 Slope (%)	1.1
	Crossing 1 Cross Slope (%)	0.6		Crossing 2 Cross Slope (%)	2
Yes	Gutter Ponding	No	Yes	Curb Slope	0.9
Yes	Gutter Lip Height (in)	0		Road Run Slope (%)	0.6
Yes	Gutter Run Slope (%)	1.4		Road Cross Slope (%)	1.3
Yes	Gutter Cross Slope (%)	0.8	No	Perpendicular Joint Present	No
Yes	Overall Surface Condition	Acceptable			
	Cross Gutter Present?	Yes		Spandrel Present?	Yes
	Replace Cross Gutter?	No		Replace Spandrel?	No

**Possible Solutions:**  
**Remove & Replace Curb Ramp With Two New Directional Ramps or Equivalent.**

**OC Std/PROW:**  
**R204.3, STD 1115**

**Total Cost:**      \$      **4000**
