# Access Compliance Report Public Rights-of-Way (Curb Ramps)

Main Street: SANTA\_CLARA\_AVE Cross Street: LORETTA\_DR Location: NW

ADA ID: RPRK211229152148 Ramp Type: Type 4 - Parallel Initial Pass/Fail: Pass Overall Compliance: No Severity Score: 0

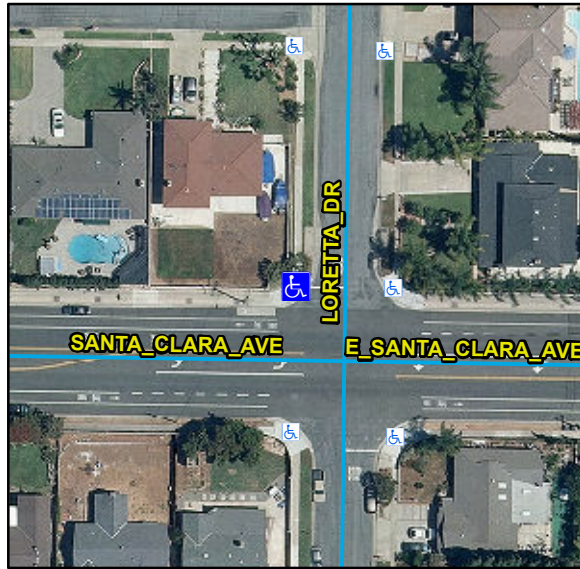
OC Std/PROW:

R304.2.2, STD 1115

| Compliance | Description | Data | Compliance | Description | Data |
|---|---|---|---|---|---|
| Yes | Gutter Ponding | No | No | Curb Slope | 10.2 |

Possible Solutions:

Remove & Replace Curb Slope.
