# Access Compliance Report Public Rights-of-Way (Curb Ramps)

Main Street: CHAPMAN\_AVE Cross Street: CANNON\_ST Location: NW

ADA ID: RPRK220103111000 Ramp Type: Type 1 - Perpendicular Diagonal Initial Pass/Fail: Fail Overall Compliance: No Severity Score: 0

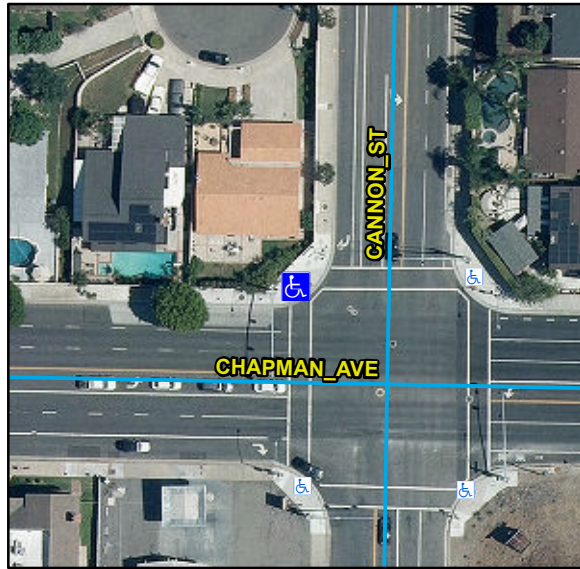
| Compliance | Description | Data | Compliance | Description | Data |
|---|---|---|---|---|---|
| N/A | Ramp Length (in) | 110 | N/A | Flare Type LT | |
| Yes | Ramp Width (in) | 48 | | | N/A |
| Yes | Ramp Run Slope (%) | 4 | N/A | Flare Slope LT (%) | N/A |
| Yes | Ramp Cross Slope (%) | 3.1 | N/A | Flare Traversable LT | N/A |
| N/A | Ramp Inside Crosswalk 1 | Yes | Yes | Ramp Inside Crosswalk 2 | Yes |
| Yes | Gutter Lip Height (in) | 0 | | Road Run Slope (%) | 3.4 |
| Yes | Overall Surface Condition: Acceptable | | Yes | Perp Joint Present | Yes |

**Remove & Replace Curb Ramp With Two New Directional Ramps or Equivalent.**

STD 1115

Total Cost: \$ 6160
