# Access Compliance Report Public Rights-of-Way (Curb Ramps)

Main Street: CANYON\_VIEW\_AVE Cross Street: N/A Location: S

ADA ID: RPRK220103113212 Ramp Type: Type 1 - Perpendicular Initial Pass/Fail: Pass Overall Compliance: No Severity Score: 25

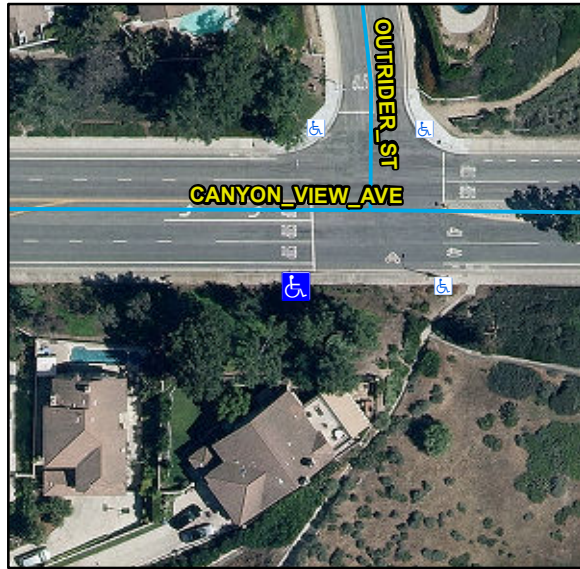
| Compliance | Description | Data | Compliance | Description | Data |
|---|---|---|---|---|---|
| No | Landing Width (in) | N/A | Yes | Flare Slope RT (%) | 5.2 |
| No | Landing Cross Slope (%) | N/A | No | DWS Provided | No |
| No | Gutter Lip Height (in) | 0.25 | | Road Run Slope (%) | N/A |
| No | Gutter Run Slope (%) | 5.3 | | Road Cross Slope (%) | N/A |

Remove & Replace Entire Ramp. Remove & Replace Gutter.
