# Access Compliance Report Public Rights-of-Way (Curb Ramps)

Main Street: CANYON\_VIEW\_AVE Cross Street: OUTRIDER\_ST Location: NW

ADA ID: RPRK220103113423 Ramp Type: Type 1 - Perpendicular Diagonal Initial Pass/Fail: Pass Overall Compliance: No Severity Score: 0

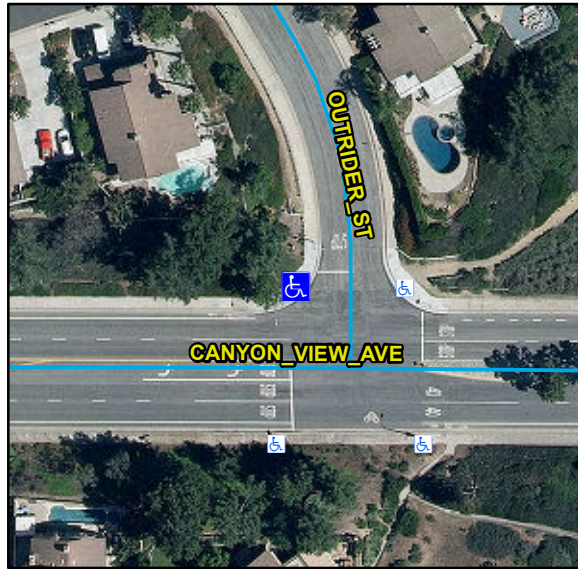
| Compliance | Description | Data | Compliance | Description | Data |
|---|---|---|---|---|---|
| Yes | Gutter Ponding | No | No | Curb Slope | 5.4 |

Remove & Replace Curb Ramp With Two New Directional Ramps or Equivalent.

R304.2.2, R304.2.1, STD 1115
