# Access Compliance Report Public Rights-of-Way (Curb Ramps)

Main Street: NEWPORT\_BLV Cross Street: SKYLARK\_PL Location: SE

ADA ID: RPRK220103115240 Ramp Type: Type 1 - Perpendicular Diagonal Initial Pass/Fail: Fail Overall Compliance: No Severity Score: 2

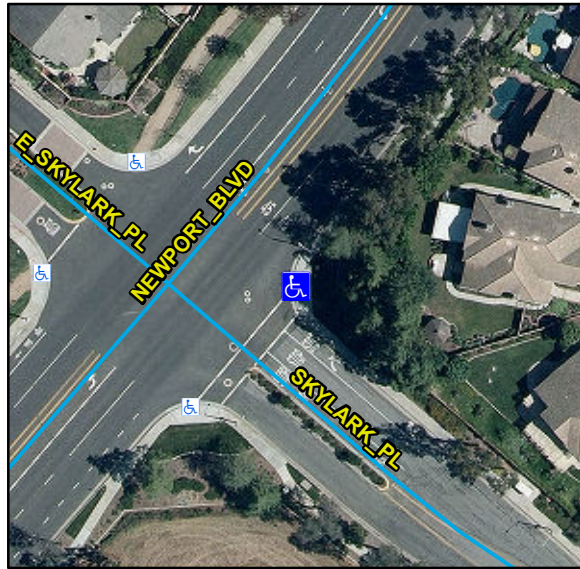
| Compliance | Description | Data | Compliance | Description | Data |
|---|---|---|---|---|---|
| No | Ramp Cross Slope (%) | 3.5 | N/A | Flare Traversable LT | N/A |

Remove & Replace Curb Ramp With Two New Directional Ramps or Equivalent.

R304.5.3, STD 1115
