# Access Compliance Report Public Rights-of-Way (Curb Ramps)

| Main Street: FURLONG_DR | | Cross Street: HUNTSMAN_RD | | Location: | W |
| ADA ID: RPRK220103120918 | Ramp Type: Type 4 - Parallel | Initial Pass/Fail: Pass | Overall Compliance: No | Severity Score: | 5 |

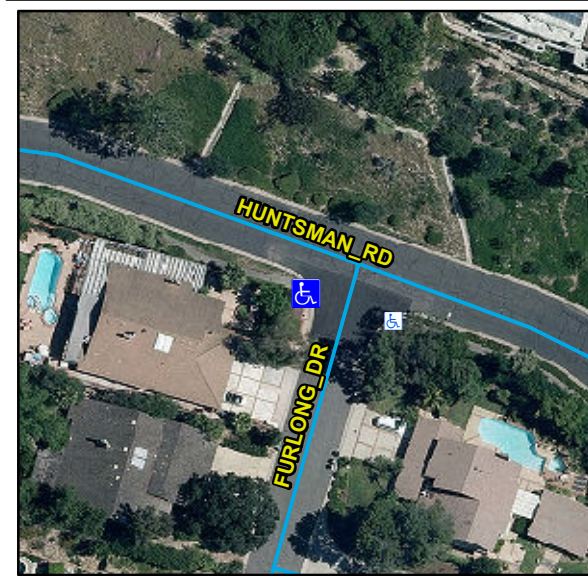
| Compliance | Description | Data | Compliance | Description | Data |
|---|---|---|---|---|---|
| Yes | Obstructions Present? | No | N/A | Utilities Present? | Yes |
| | Obstruction Dimensions | N/A | | Pull Box | |

| Compliance | Description | Data | Compliance | Description | Data |
|---|---|---|---|---|---|
| No | Gutter Run Slope (%) | 5.8 | | Road Cross Slope (%) | 4.7 |

Possible Solutions:

Remove & Replace Gutter. Utility Present.

R304.5.4, STD 1115
