# Access Compliance Report Public Rights-of-Way (Curb Ramps)

Main Street: REDBERRY\_RD Cross Street: RANCHWOOD\_RD Location: NE

ADA ID: RPRK220103122901 Ramp Type: Type 1 - Perpendicular Diagonal Initial Pass/Fail: Pass Overall Compliance: No Severity Score: 2

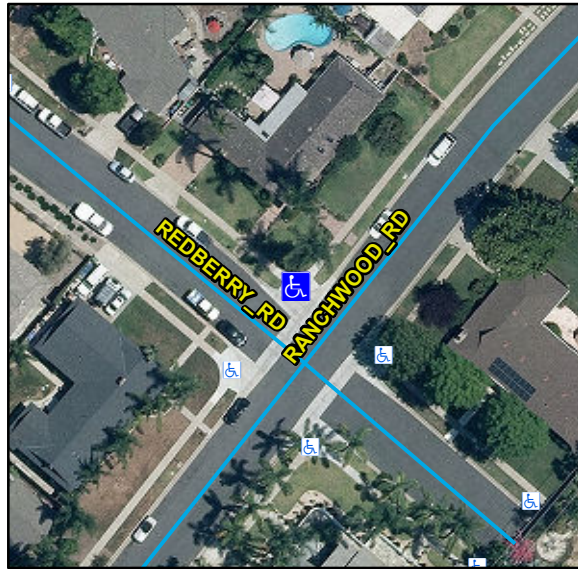
| Compliance | Description | Data | Compliance | Description | Data |
|---|---|---|---|---|---|
| Yes | Gutter Ponding | No | No | Curb Slope | 10.5 |

Remove & Replace Curb Ramp With Two New Directional Ramps or Equivalent.

R304.2.2, R304.2.1, STD 1115
