# Access Compliance Report Public Rights-of-Way (Curb Ramps)

Main Street: RANCHWOOD\_RD Cross Street: REDBERRY\_RD Location: NW

ADA ID: RPRK220103123147 Ramp Type: Type 1 - Perpendicular Diagonal Initial Pass/Fail: Pass Overall Compliance: No Severity Score: 5

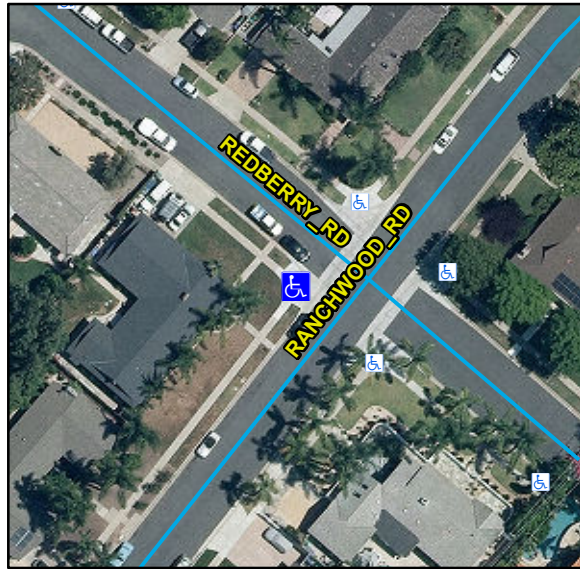
| Compliance | Description | Data | Compliance | Description | Data |
|---|---|---|---|---|---|
| No | Gutter Run Slope (%) | 5.2 | | Road Cross Slope (%) | 2.9 |
| No | Gutter Cross Slope (%) | 4.2 | | | |

Remove & Replace Landing. Remove & Replace Gutter.
