# Access Compliance Report Public Rights-of-Way (Curb Ramps)

| Main Street: REDBERRY_RD | | Cross Street: EVENINGSIDE_DR | | Location: | SW |
| ADA ID: RPRK220103123712 | Ramp Type:Type 1 - Perpendicular Diagonal Initial Pass/Fail: Fail | | Overall Compliance: No | Severity Score: | 15 |

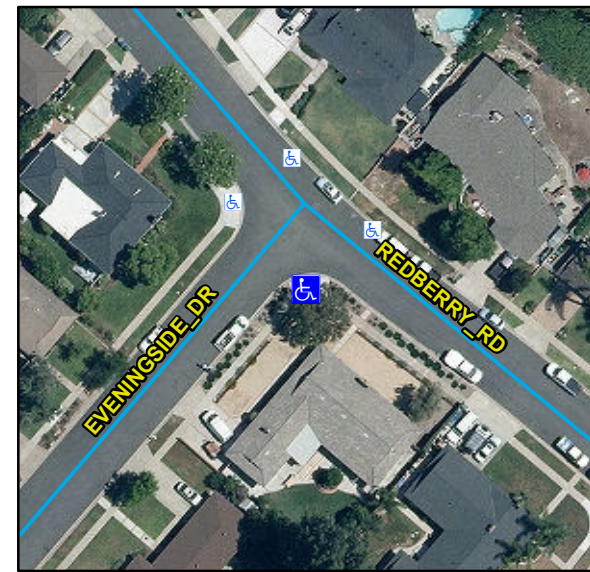
| Compliance | Description | Data | Compliance | Description | Data |
|---|---|---|---|---|---|
| No | Ramp Run Slope (%) | 9.2 | N/A | Flare Slope LT (%) | N/A |

**Remove & Replace Curb Ramp With Two New Directional Ramps or Equivalent.**

**R304.2.2, STD 1115**
